August 2008 Unit 2 Transformer Failure
Susan Westcott
Engineering Director
10/07/08

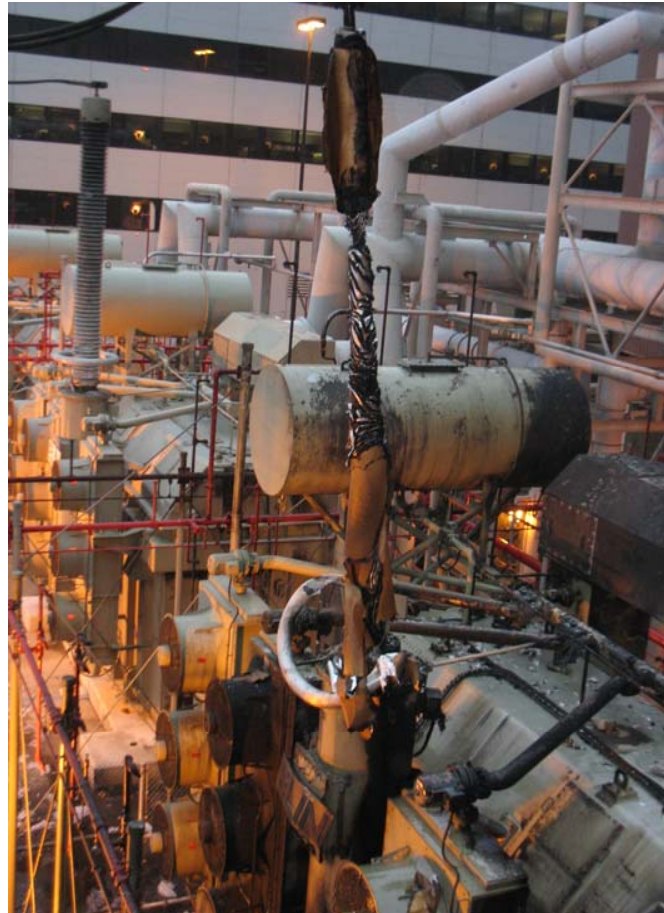
- At 2356 on 8/16/08, a failure related to the Unit 2 Main Transformer (MT) "C" phase resulted in a Unit trip and a Reactor trip.
